Using NOAA historical charts, maps, aerial photography, Digital Coast and other satellite imagery to establish the status and threats to remnant tidewater rice fields and canal systems along the Lower Cape Fear River, NC

Coastal GeoTools 2015
Charleston SC, March 31, 2015

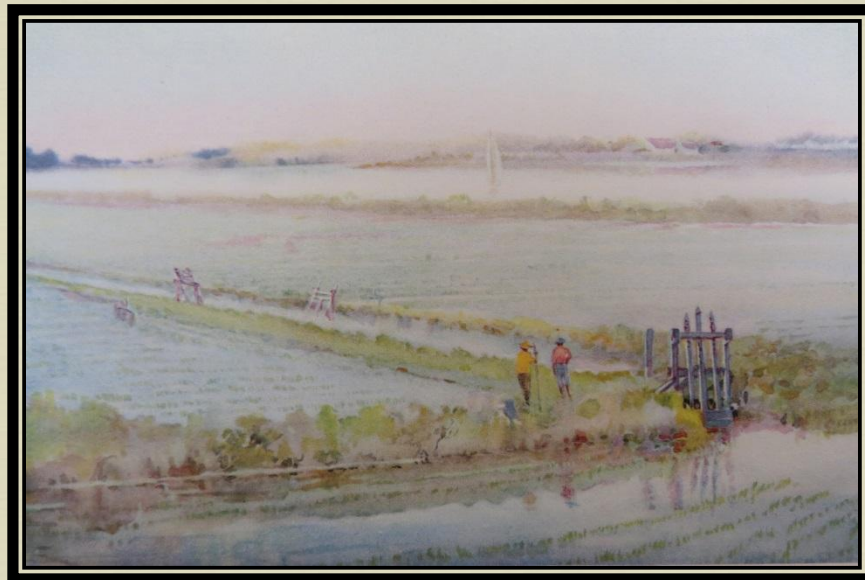
Where and when was rice cultured in the Lower Cape Fear Region?

- 1731 to 1930
- 5,000 acres on 28 plantations in 1860

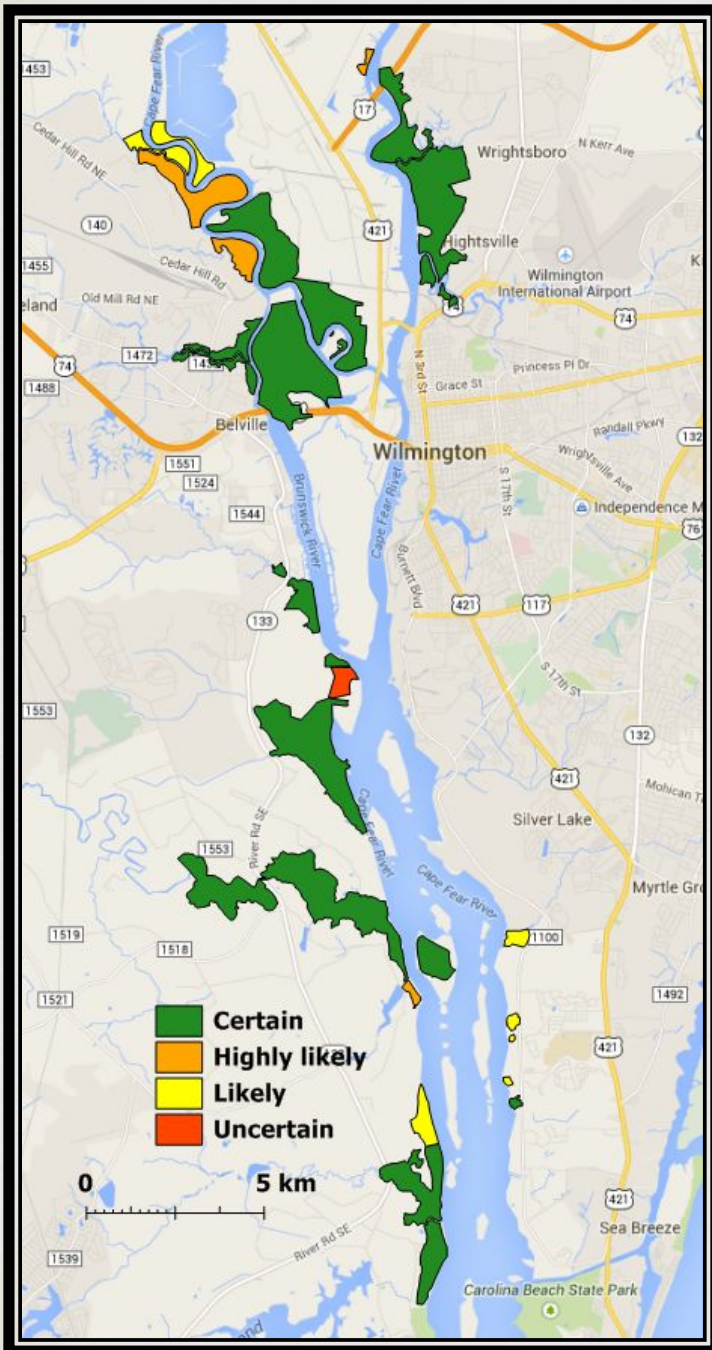
What remains of tidewater rice farming in the Lower Cape Fear Region?

- 1860 estimate of maximum extent of rice = 2,024 ha (5,000 a)
- Remains still discernable in the present day = 2,610 ha (6,449 a)

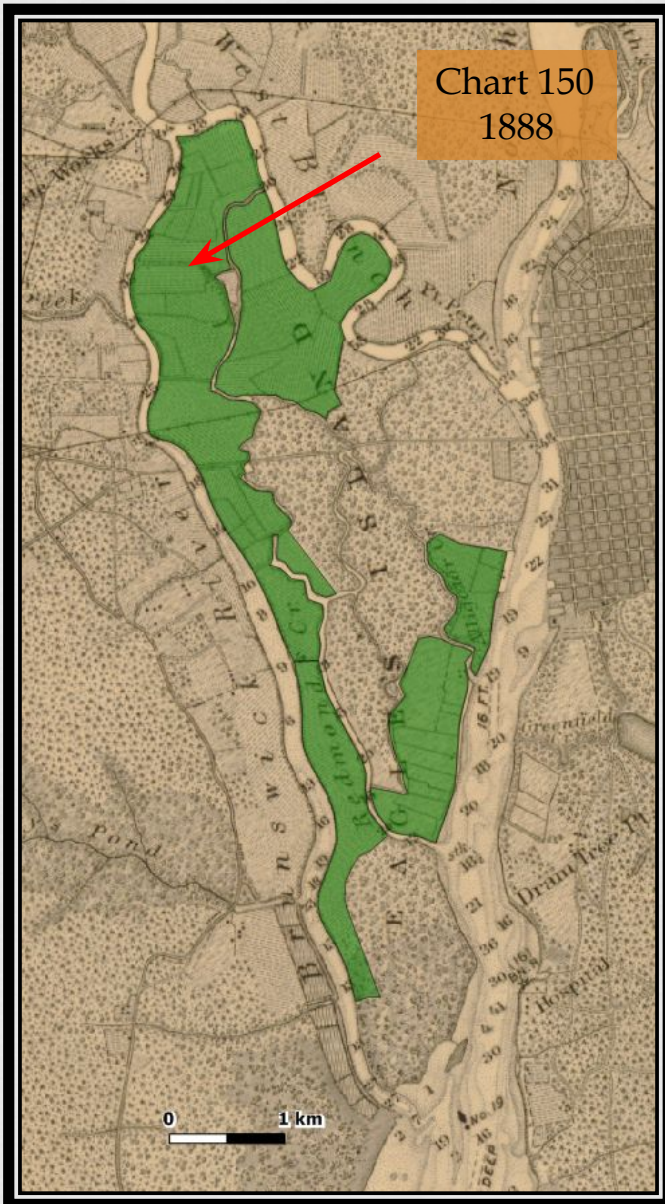
Where was rice
farmed on Eagles
Island and what
was the area
under
cultivation?

- 653 hectares
maximum expanse
of rice
- 50% of island area

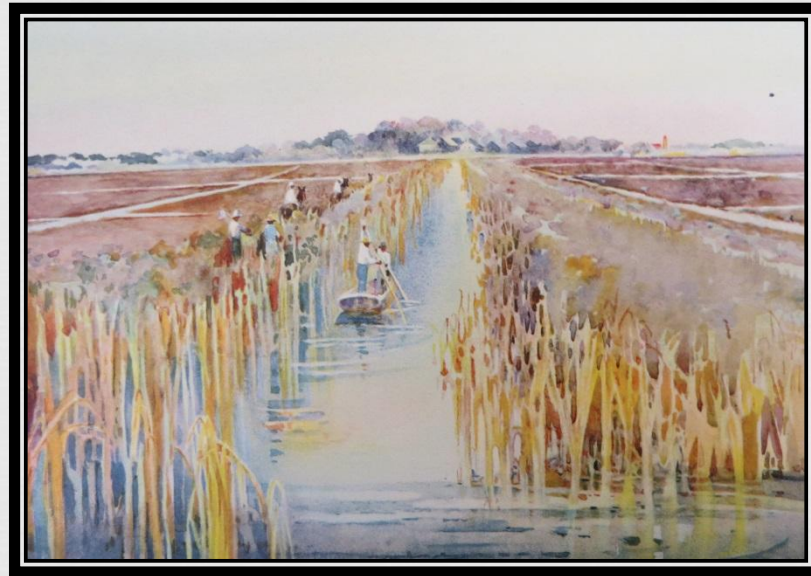
What remains of the rice canal system on Eagles Island?

Canal type	Number	Length (km)
Main	83	17.7
Peripheral	79	6.6
Ditch	454	16.3

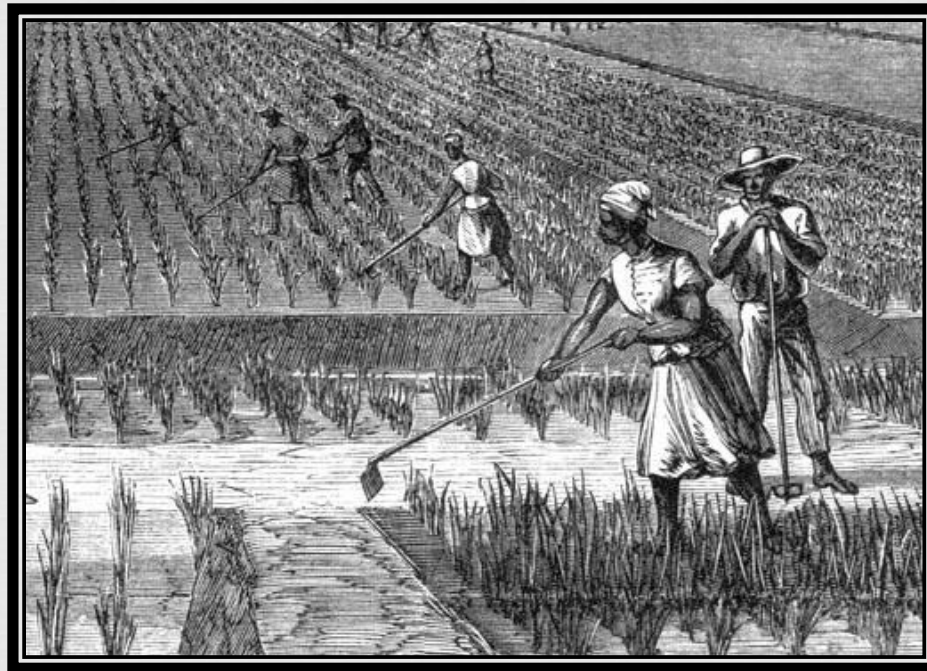
How many rice fields can be still be identified on Eagles Island?

Rice Fields	
Number	18
Total area (ha)	86.6
In relation to the maximum extent of rice	13%
In relation to the extent of present-day rice remains	26%

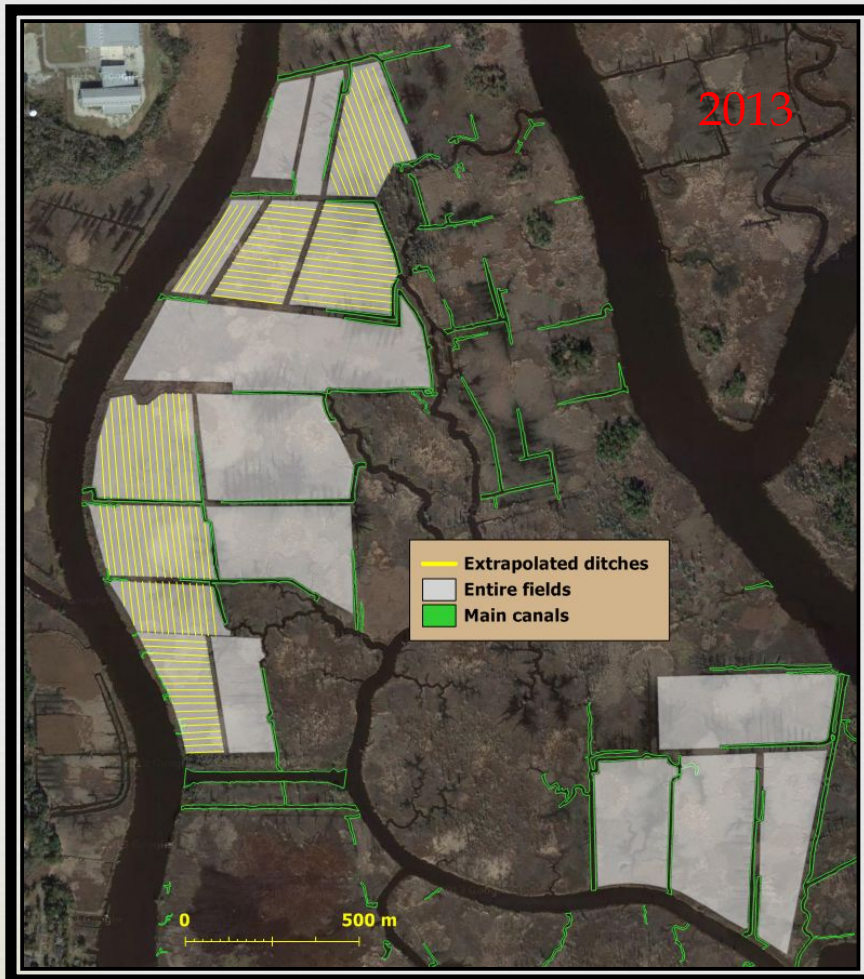
In how many fields can fragments of ditches be digitally restored?

Ditch-Extrapolated Fields	
Number	8
Total area	31.6 ha
In relation to the maximum extent of rice	4.8%
In relation to the extent of present-day rice remains	9.7%

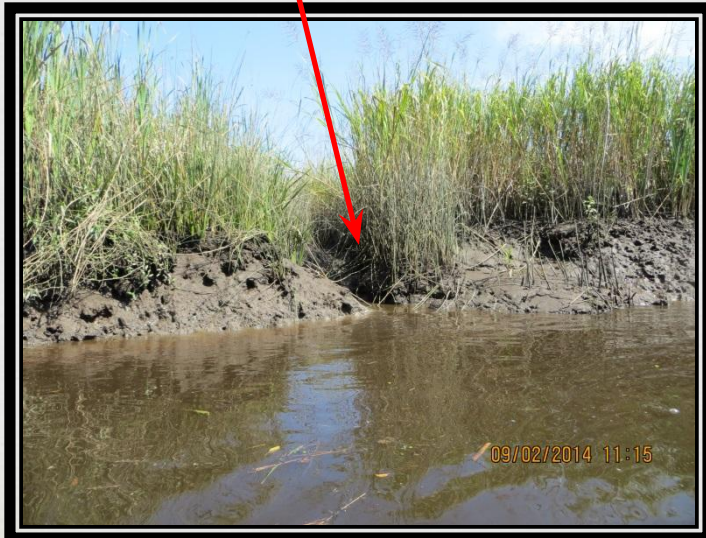
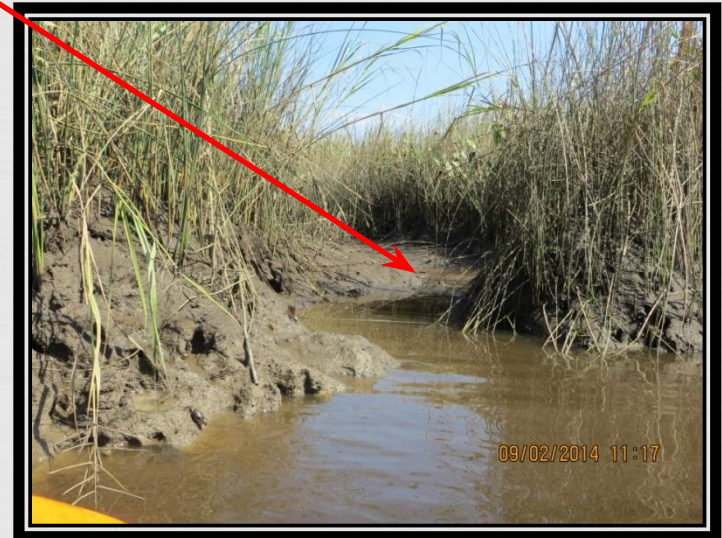
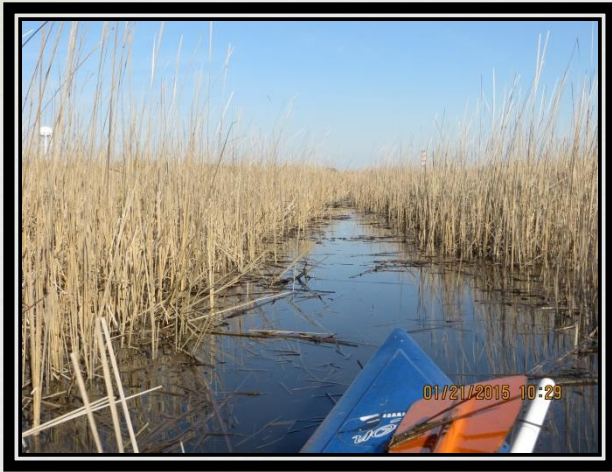
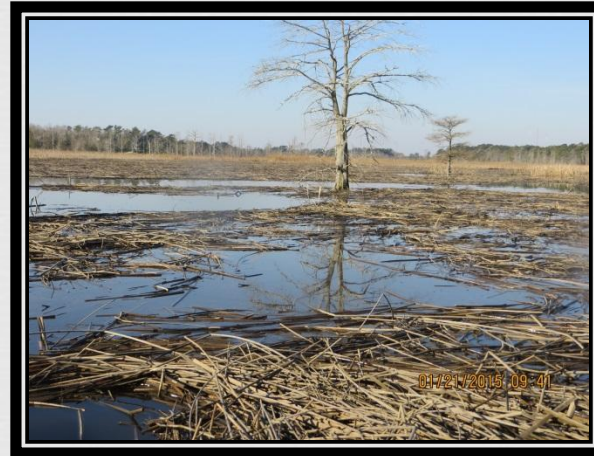
What does
ditch erosion
look like?

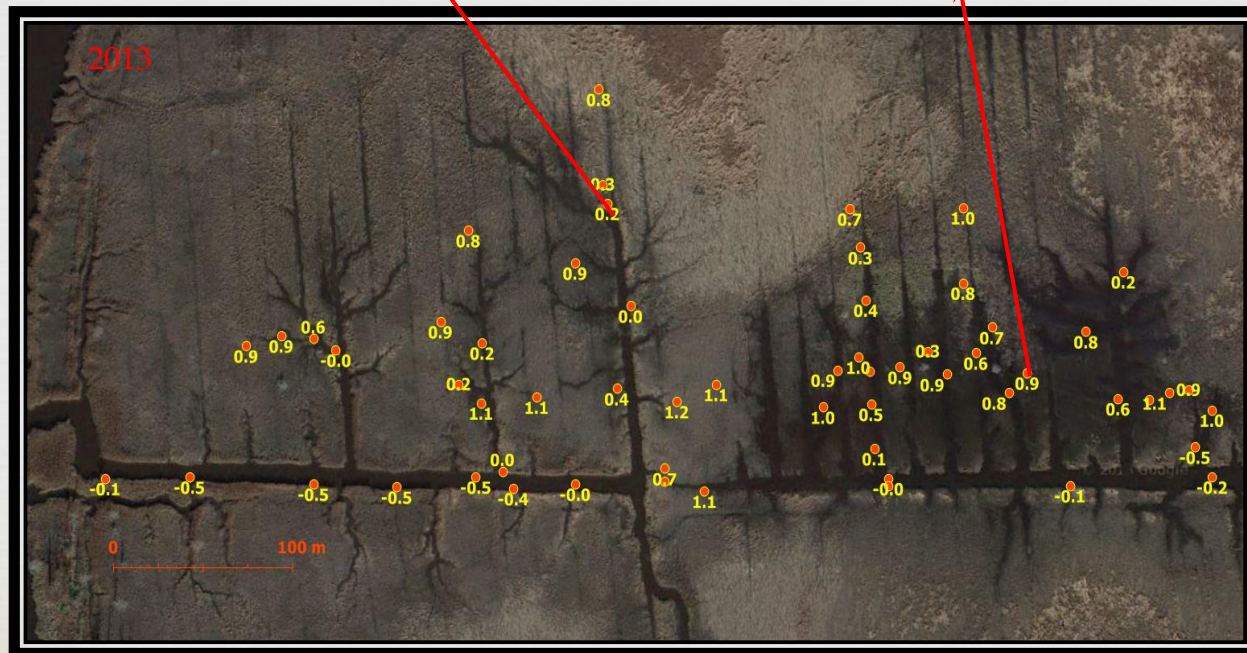
What did
the field
verification
show?

Height above MLLW
on 1/21/15

- Range -0.5 to 1.2 m
- Level of marsh
ca. 1.0 to 1.2 m

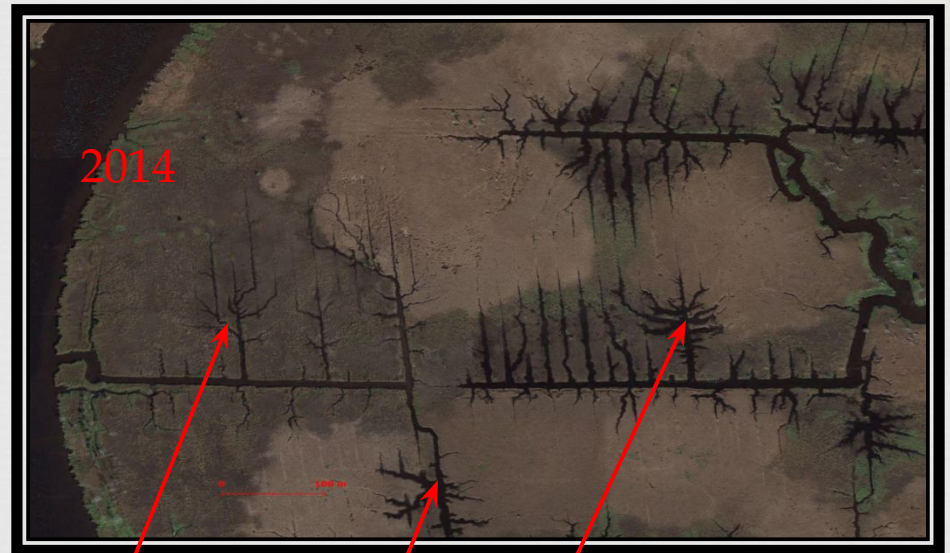
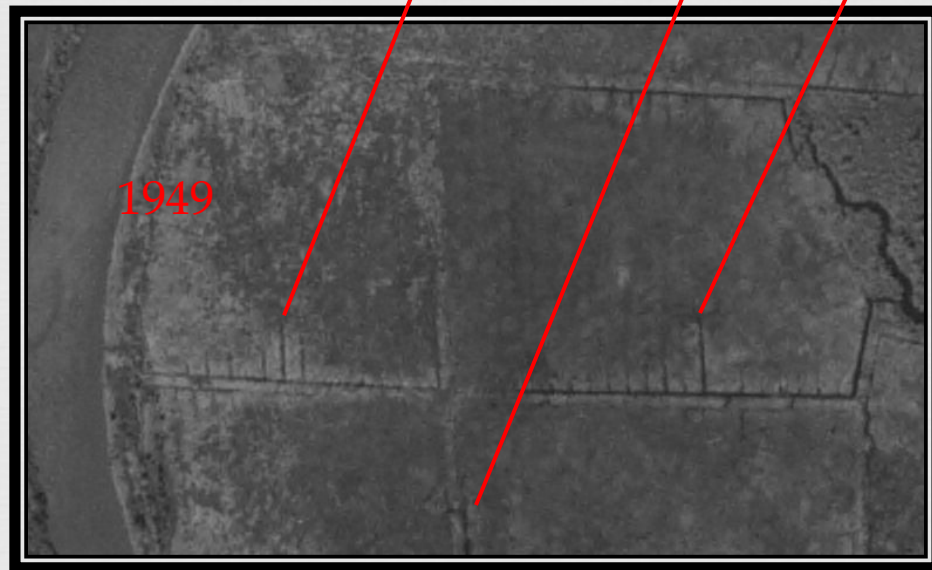
To what extent
have ditches
eroded over
65 years?

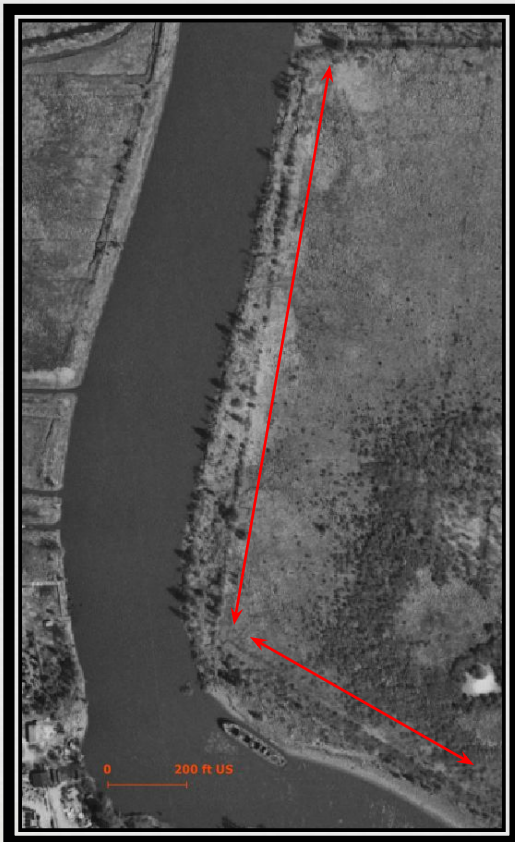
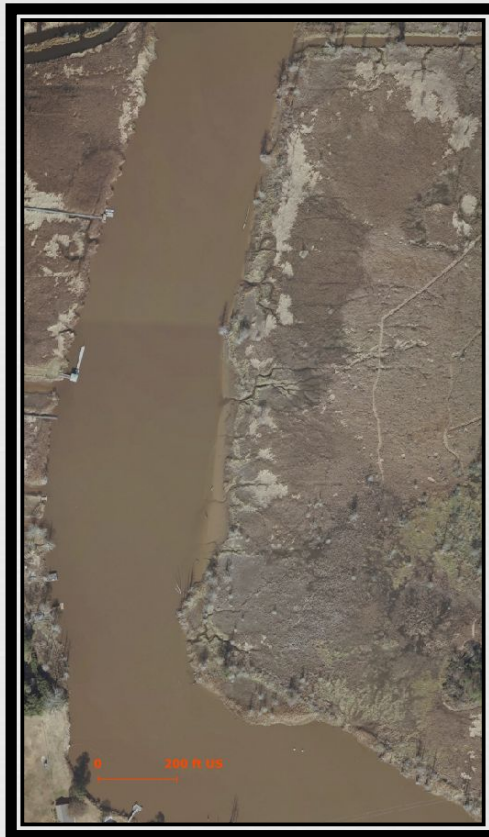
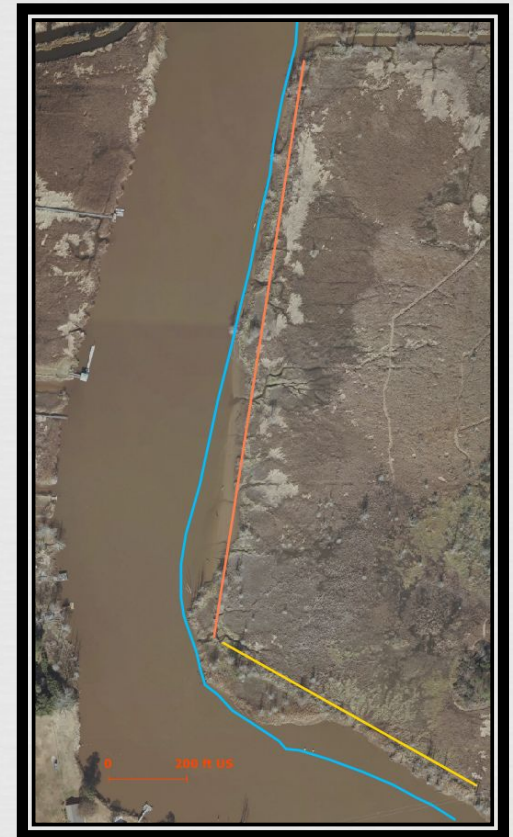
How have rice field embankments changed over 41 years?

1969 over 2010

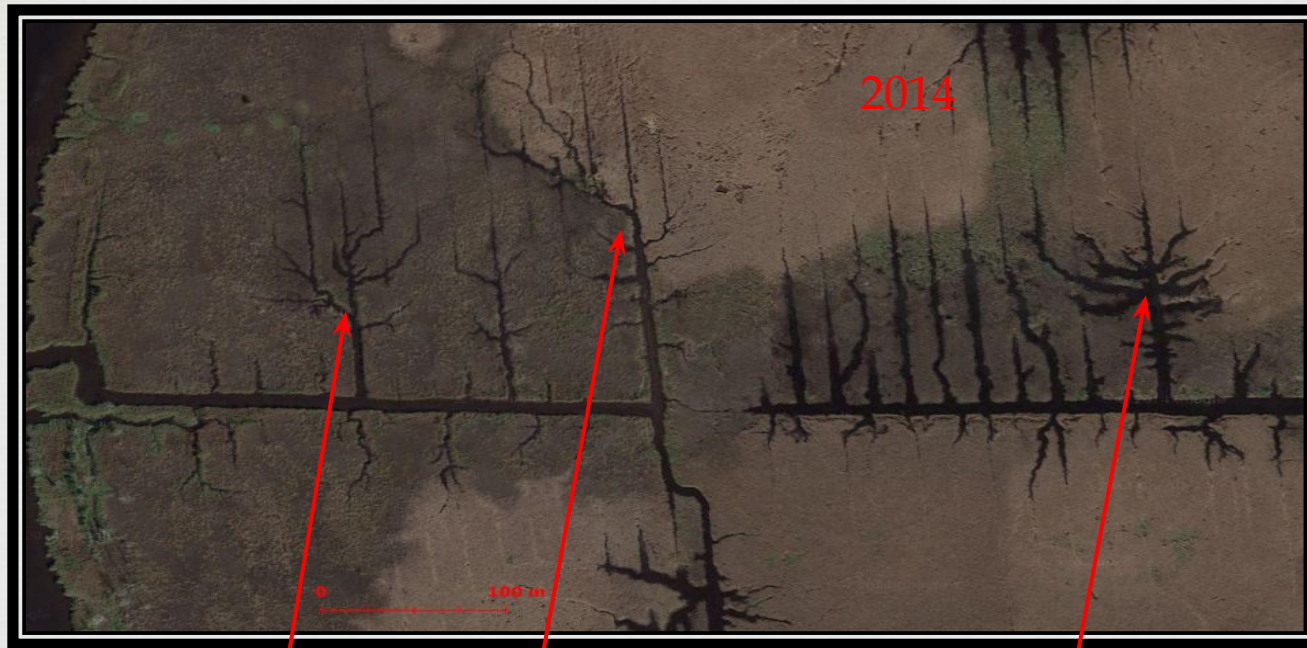
Could
LiDAR
help to
quantify
ditch
erosion?

-1.0 to 0.4 m = range
from greater to
lesser depth of erosion

0.4 to 0.6 m = level of
marsh
