Updating the Remains of the Wilmington and Manchester Railroad near Wilmington NC using Historical Nautical Charts, High Resolution Aerial Photos, and GIS

A presentation prepared for the Eagles Island Coalition
by

James McDaid Kapetsky, Ph.D.
November 8, 2015

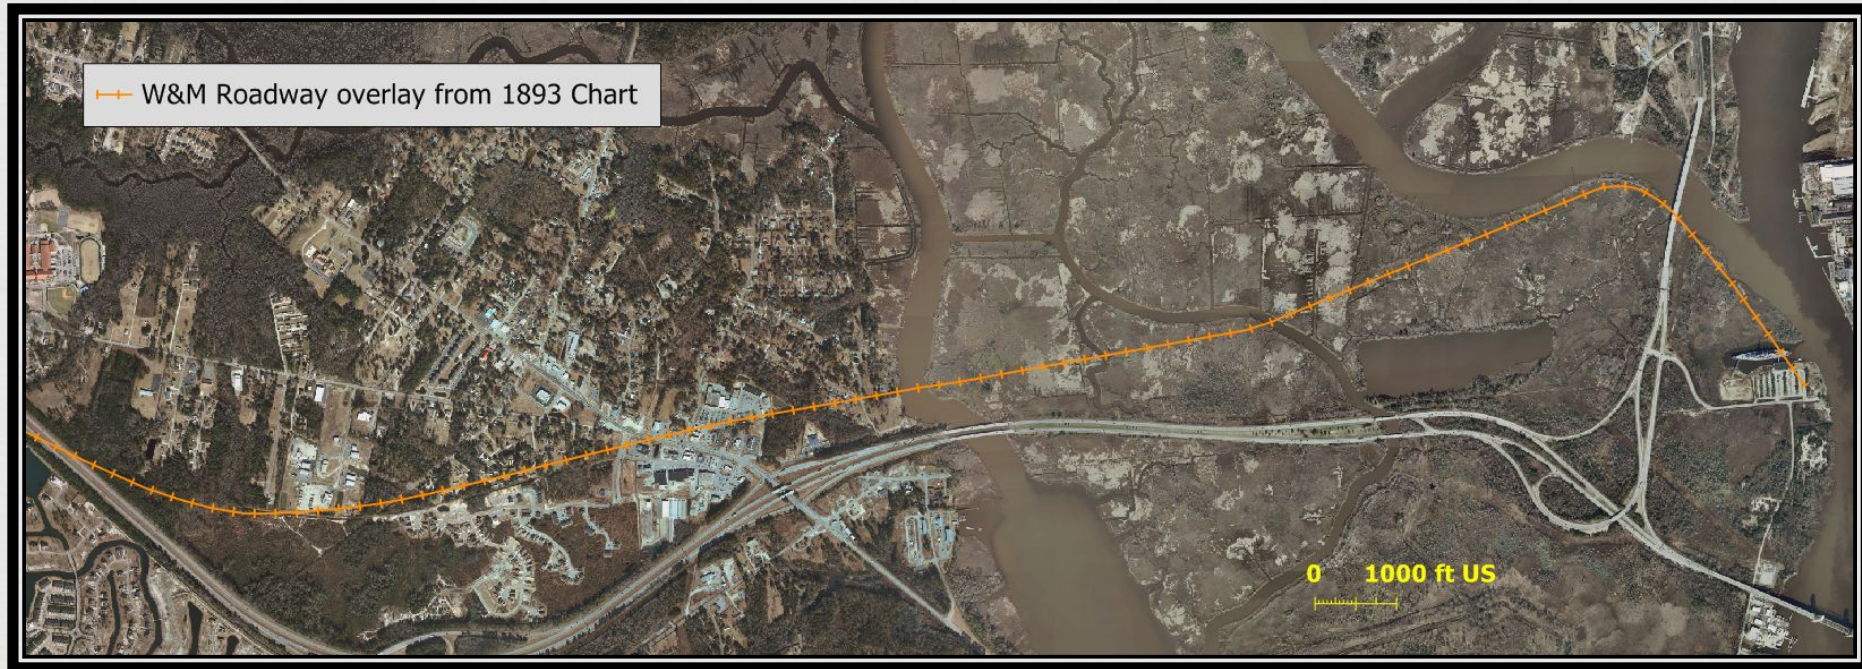
The W&M Roadway from Chart 425 of 1893 overlaid on High Resolution Orthophotos from 2010 ¹

¹ The roadway in the vicinity of the Battleship North Carolina is shown on Chart 150, but not on Chart 425

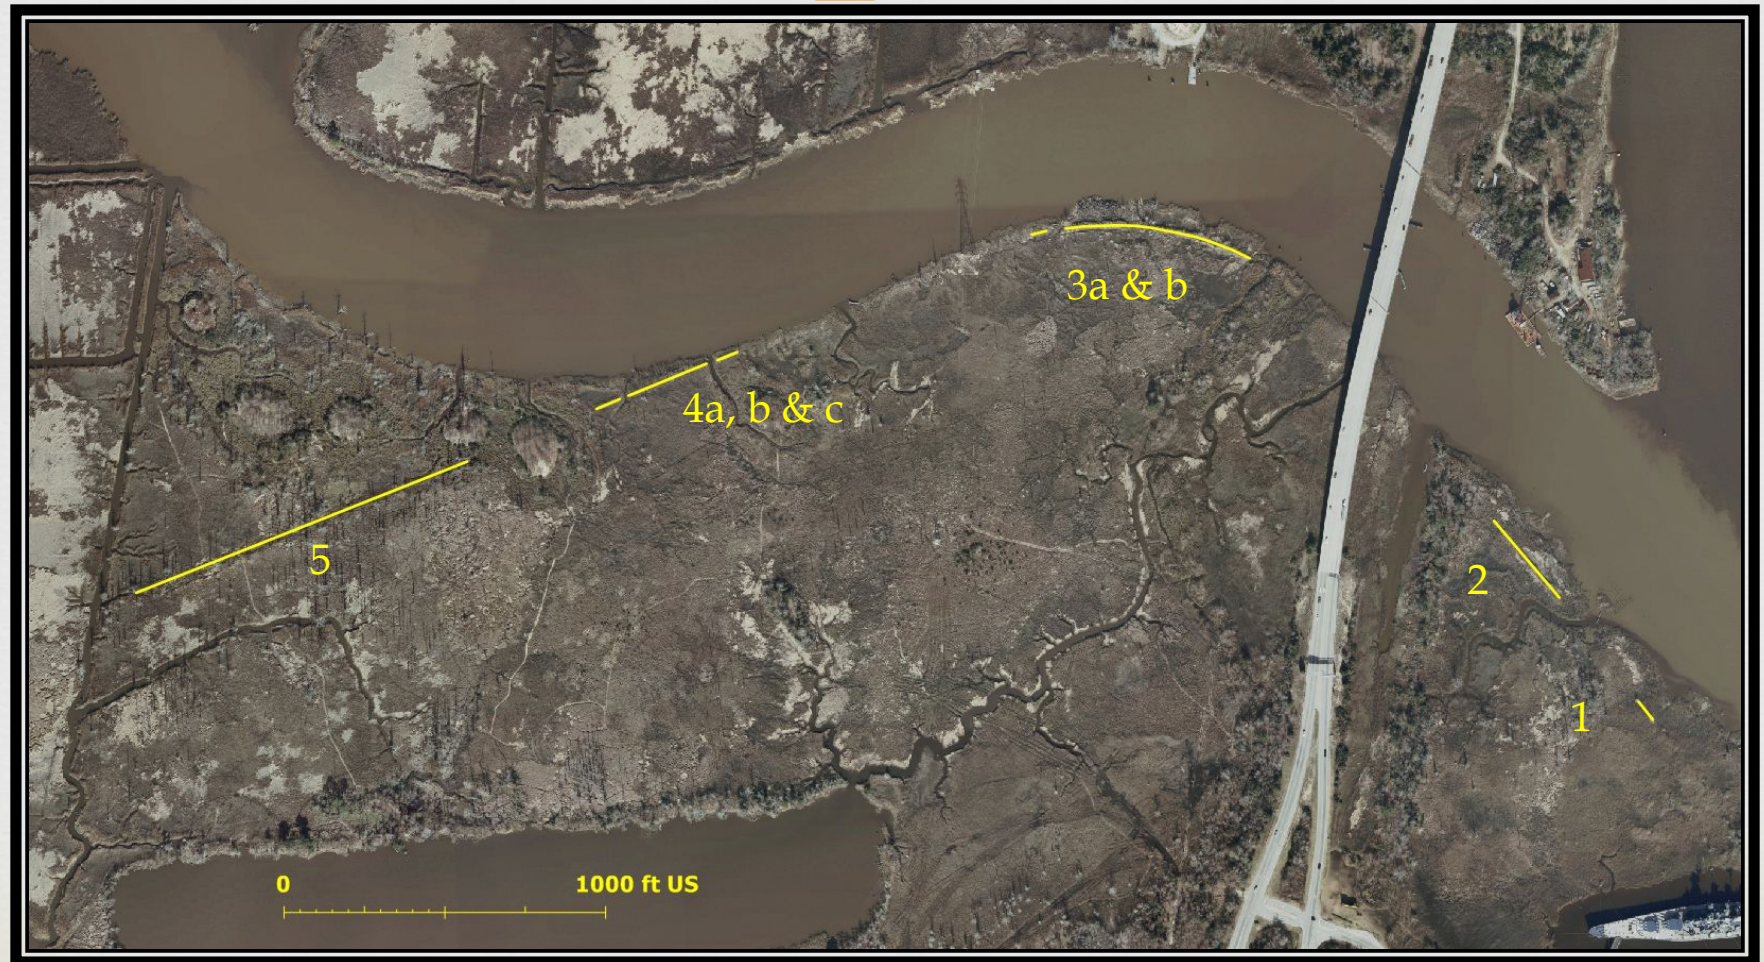
Highlighted Visible Remains of the W&M Roadway on High Resolution Orthophotos from 2010

Segment	Length (ft)
1	26
2	96
3a	179
3b	14
4a	20
4b	80
4c	24
5	337
Total	776

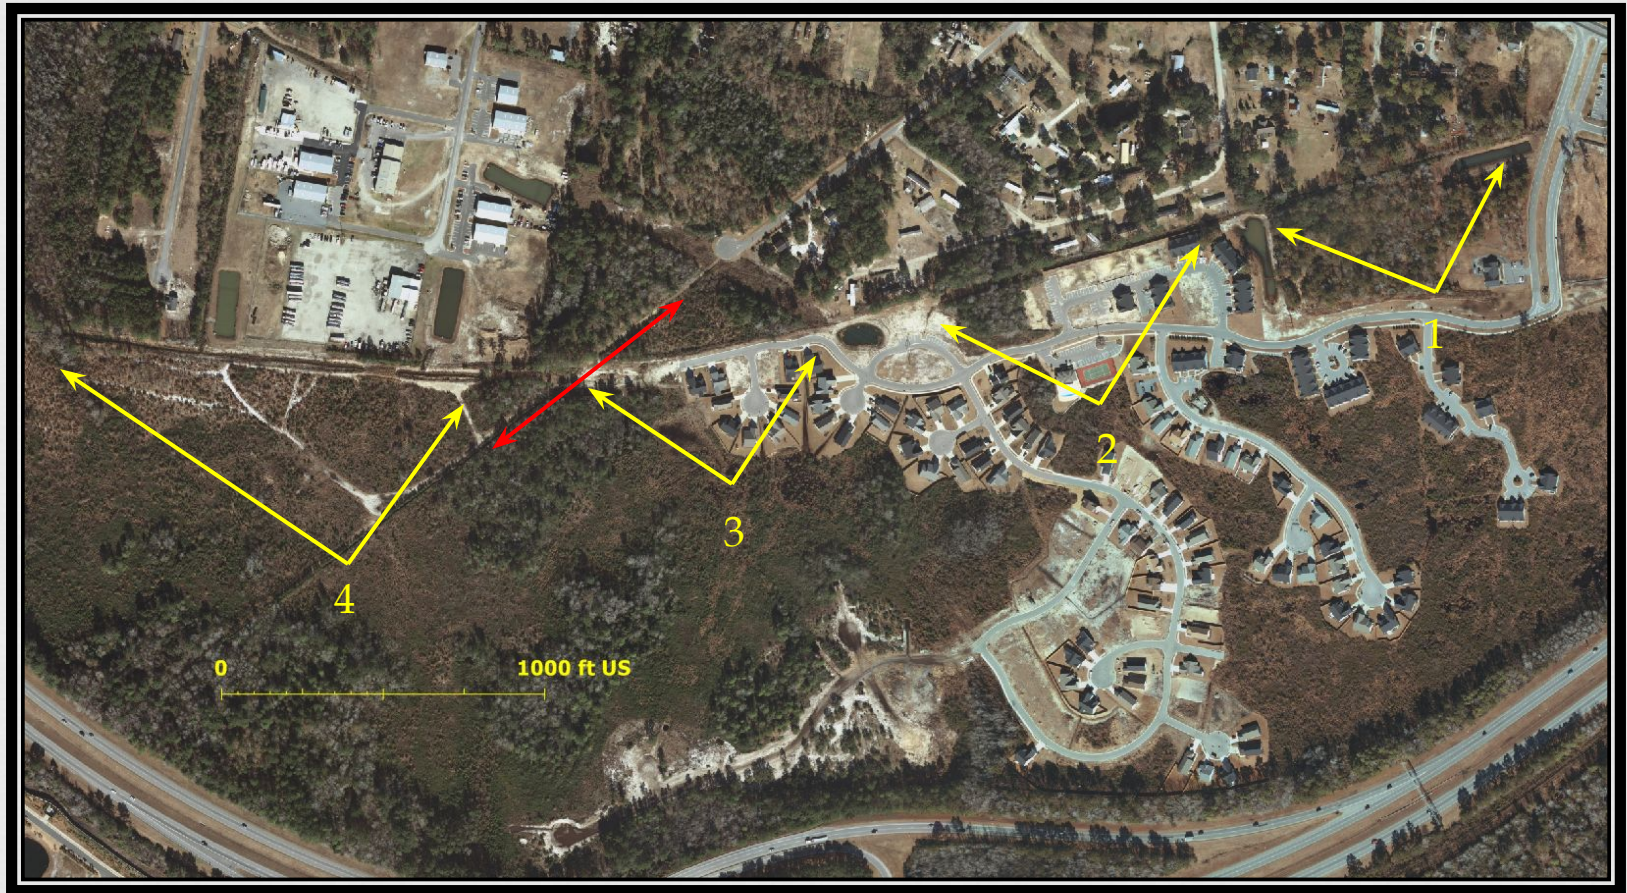
Visible Remains of the W&M Roadway in Leland on High Resolution Orthophotos from 2010

Note from C. Kernan: The diagonal line (red) running NE to SW crossing the W&M roadway at the west end of Segment 3 is the roadway of the Wilmington, Brunswick and Southern RR.

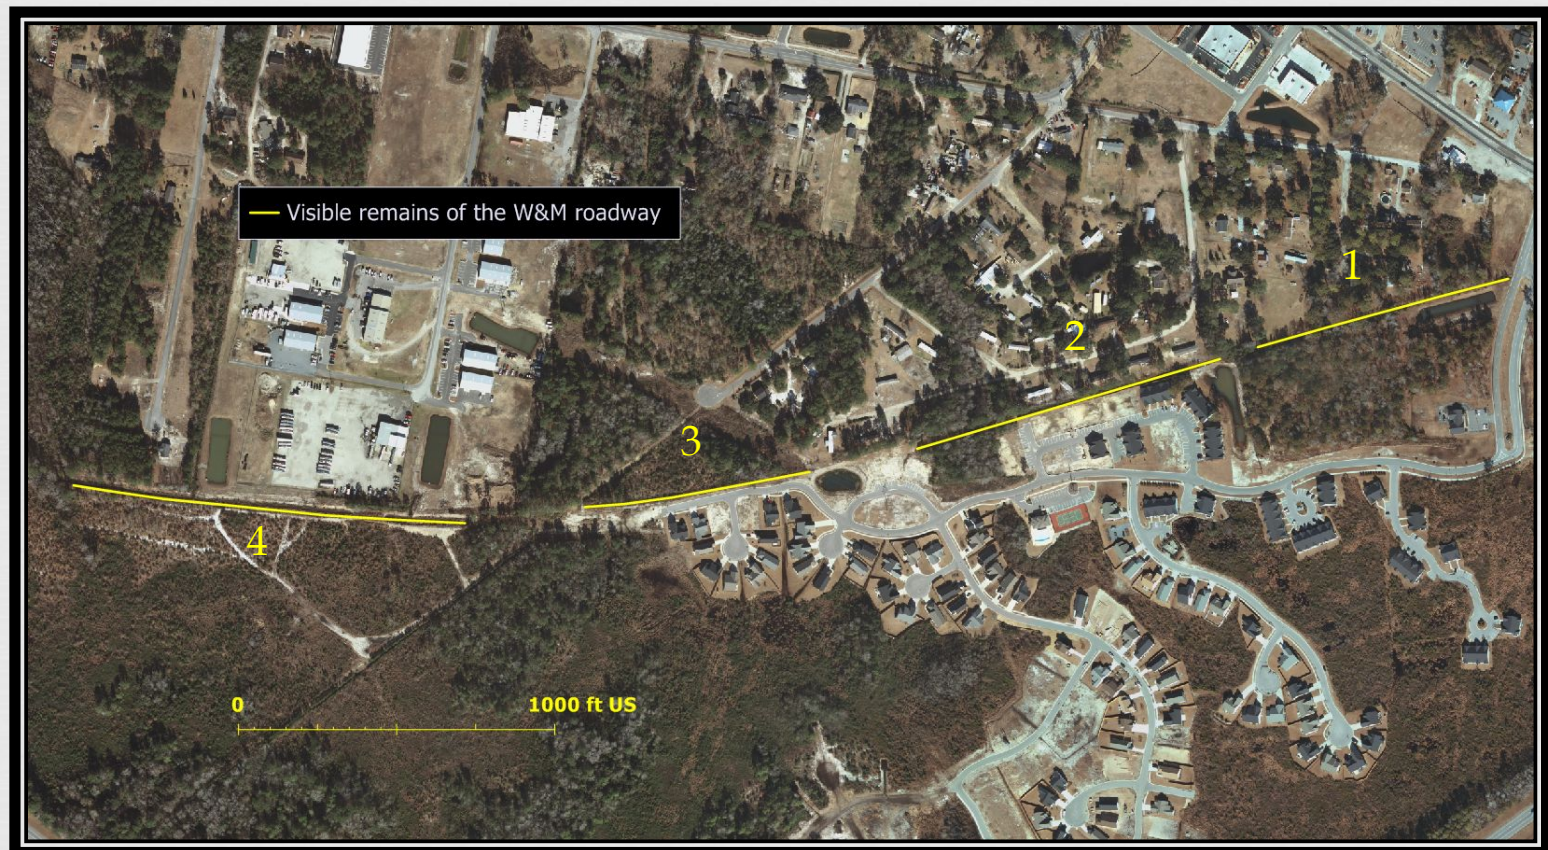
Highlighted remains of the W&M Roadway on High Resolution Orthophotos from 2010

Segment	Length (ft)
1	250
2	304
3	219
4	379
Total	1,152

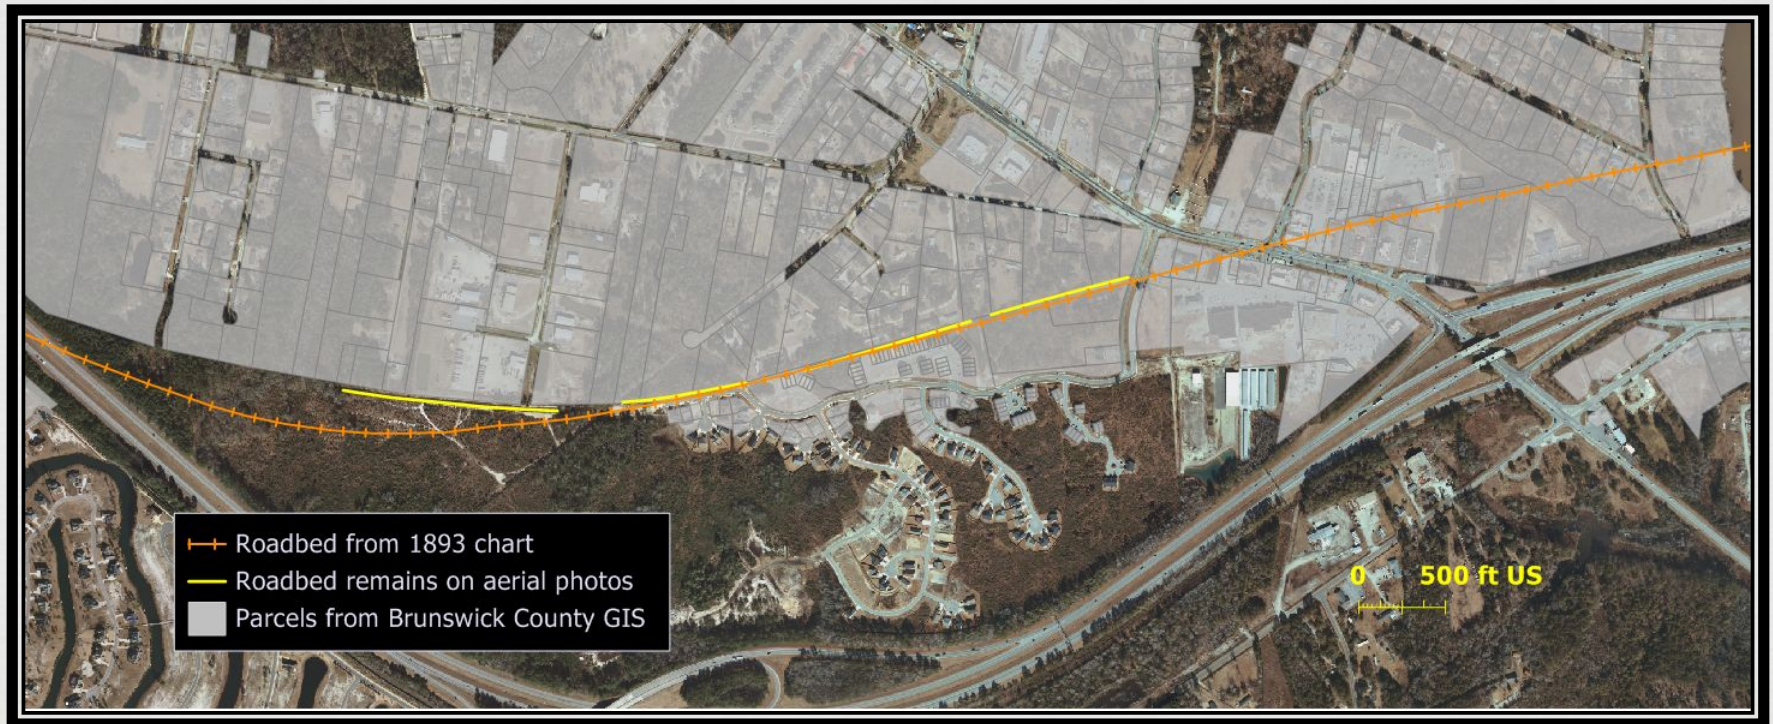
Verification by Property Lines: Visible remains coincide with property lines; charted roadbed is mostly coincident with the property lines

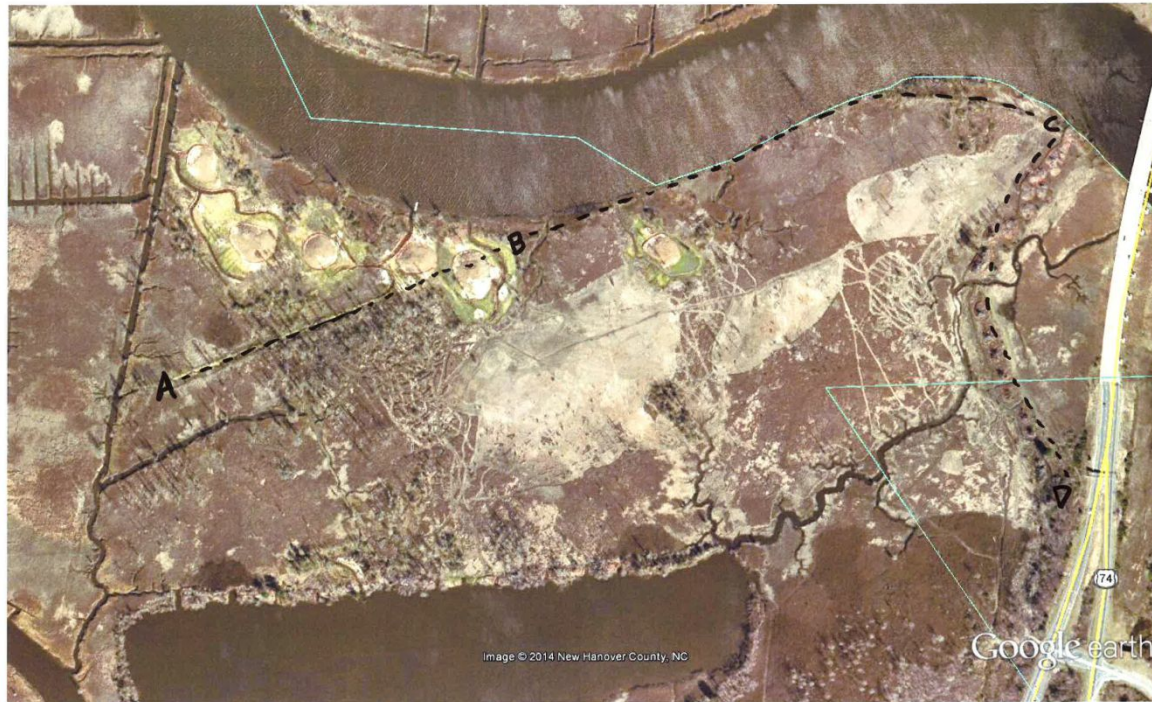
Google Maps Image from Rob Moul Used to Describe the W&M Roadbed

- "I remember looking at most of the RR bed segments back then and only the segment from "A" thru "B" on the attached 2002 Google map was raised (see following slides). Segment "B" to "C" was all covered with coastal wetlands vegetation (giant cordgrass, cattails, and *Phragmites*) and had no restoration potential. I believe a segment of the railroad bed ran from "C" near the shoreline to the vicinity of the Battleship."²

Image annotated by Rob Moul and described on previous slide

- "In summary these old rail road beds are either part of an old marsh restoration project or are regulated coastal and 404 wetlands due to their low elevations and saturation conditions. The coalition would need elevated walkways across these sites in order to gain access to the 6 elevated spoil mounds that were constructed during the 1998 DOT spoil island mitigation project."

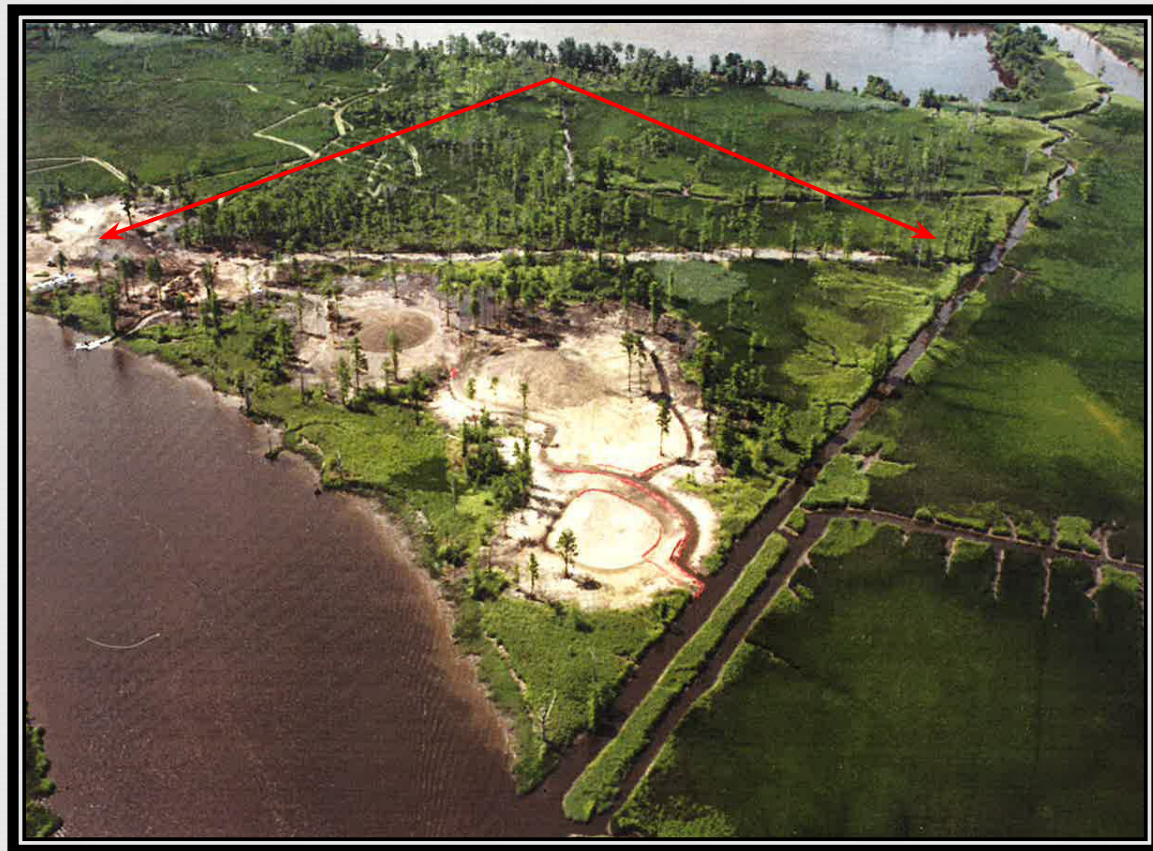
W&M Roadbed in the Vicinity of the Cape Fear River and Meares Cut during Mitigation Work

Photo by Rob Moul; Red arrows define the Section A-B of Moul that corresponds to Segment 5 in this report

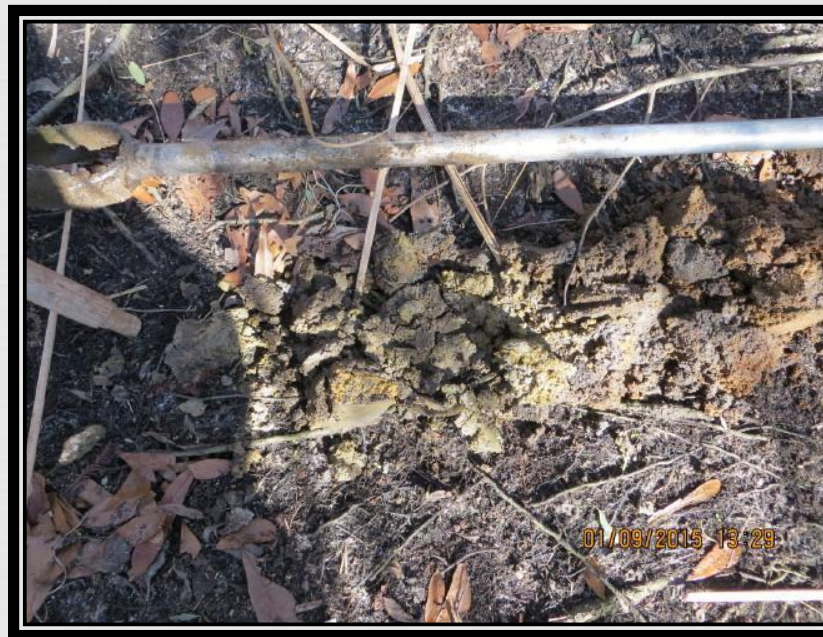
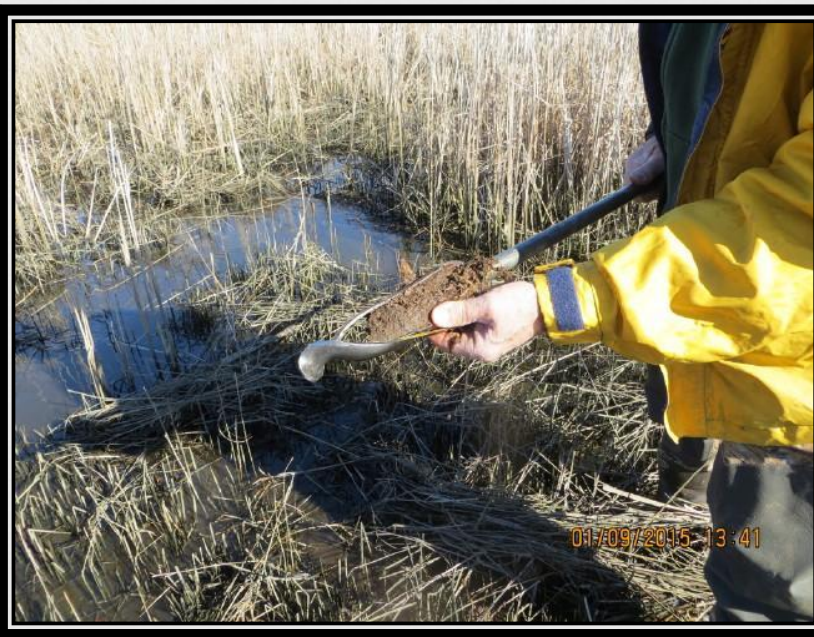
Comparison of Soil Auger Samples on the W&M Roadbed and Adjacent Marsh on the “Curve” Segment (3a)

Photos 1/9/15. The W&M roadbed soil is sandy, probably indicating that sand was added to raise and stabilize the roadbed. In contrast, the soil from the adjacent marsh was high in organic material

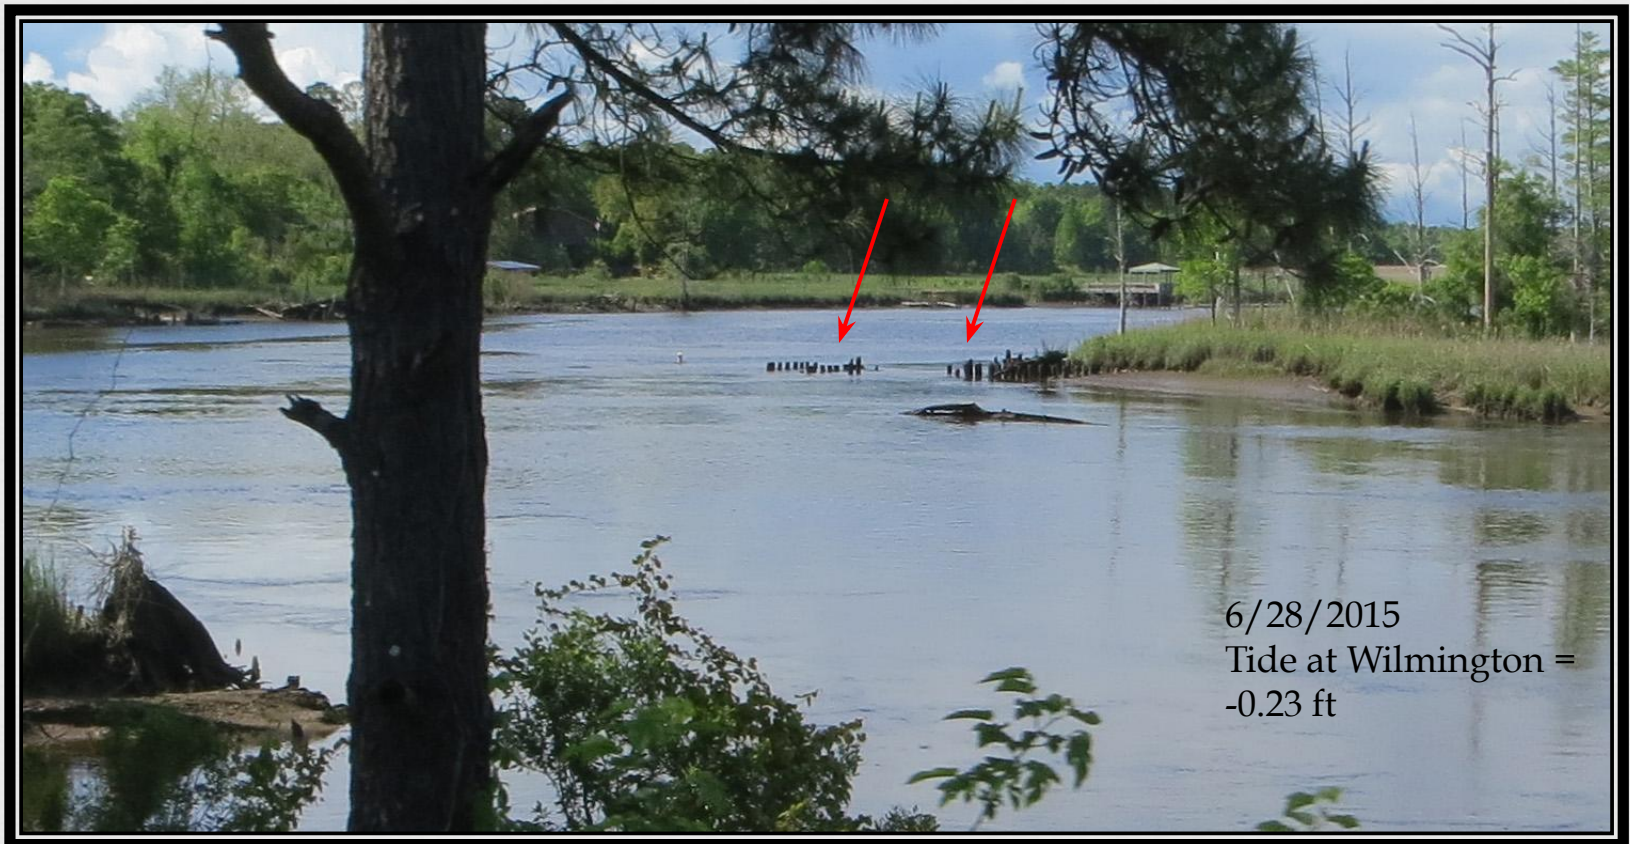
The Remains of the Brunswick River Trestle Viewed from the Route 74/76/17 Bridge

Tide at Wilmington =
-0.23 ft

The object in the foreground downstream from the trestle is the wreck of the barge Harry J. Sheridan, the history of which was described in a Wilmington Star News article in September, 1995

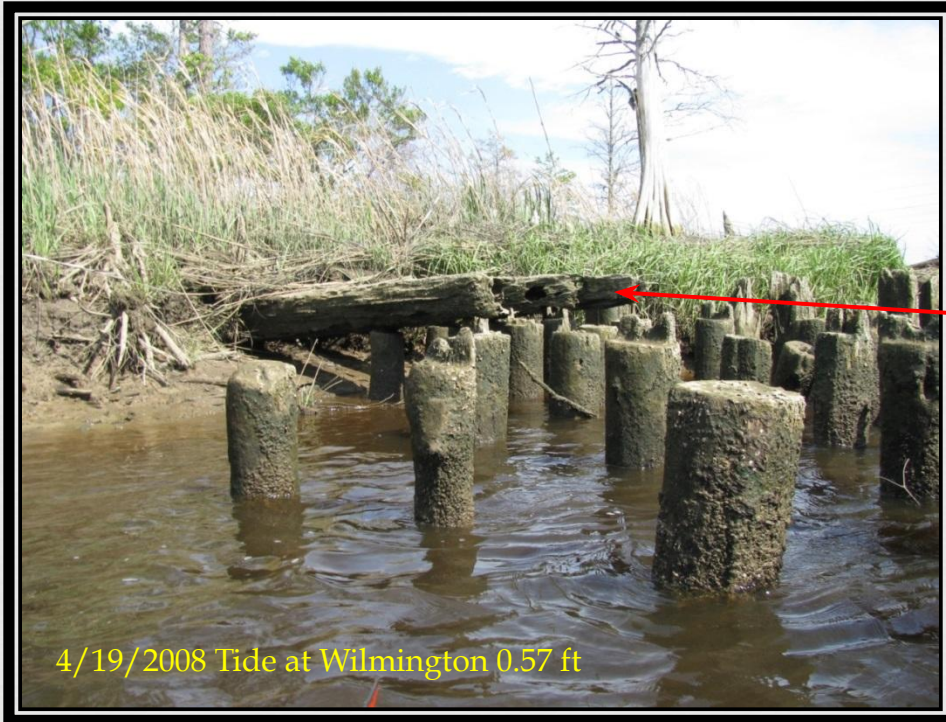
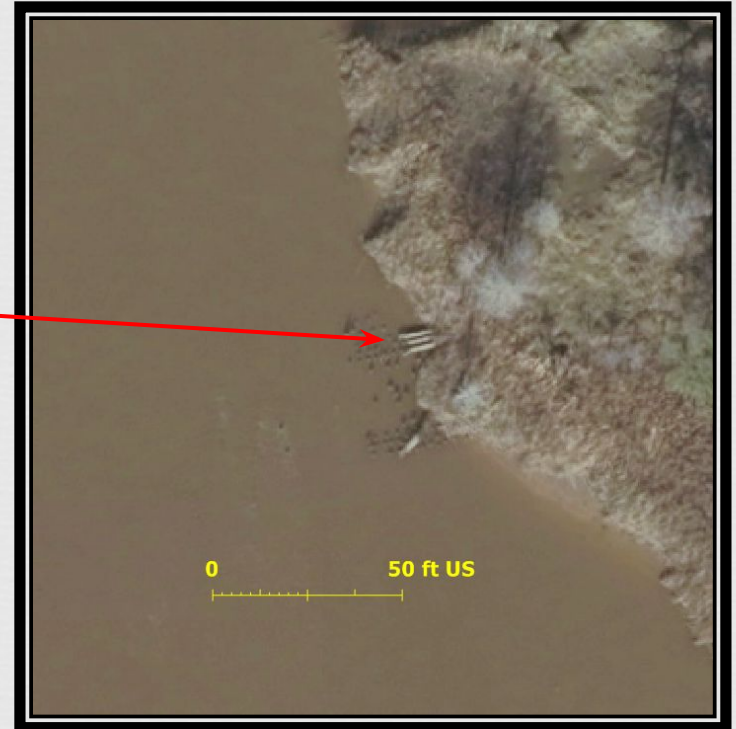
Close Up and Aerial View of the Remains of the Brunswick River Trestle

Trestle identified by Kernan, 1985 p.5 *op. cit.*; photographed by Newber, 2001 p.22 *op. cit.*

- E-mailed comments by Mark Koenig, Wilmington Railroad Museum, on viewing the close-up photographs of the trestles (5/29/15)
 - “In the case of Brunswick River and Alligator Creek, I think a solid case can be made for vintage-appropriate construction. I have some reservations about the Redmond Creek structures, though - superficially, they appear to be too new to match with the others”¹
 - “...my impression is that the structures were of a type commonly used across soft/tidal flatlands, driven in and assembled with some speed so as to get a line in operation as quickly as possible. Native timber was readily available, and techniques had already had a couple of decades to be established.”

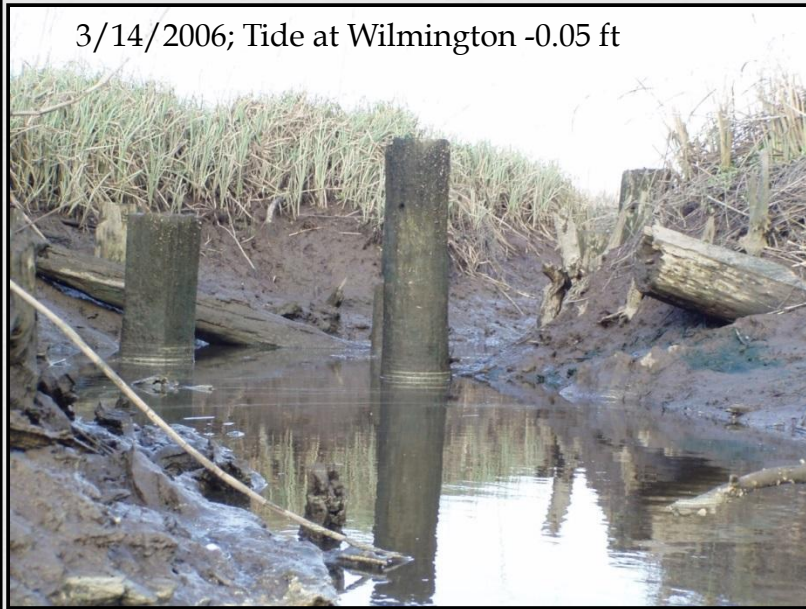
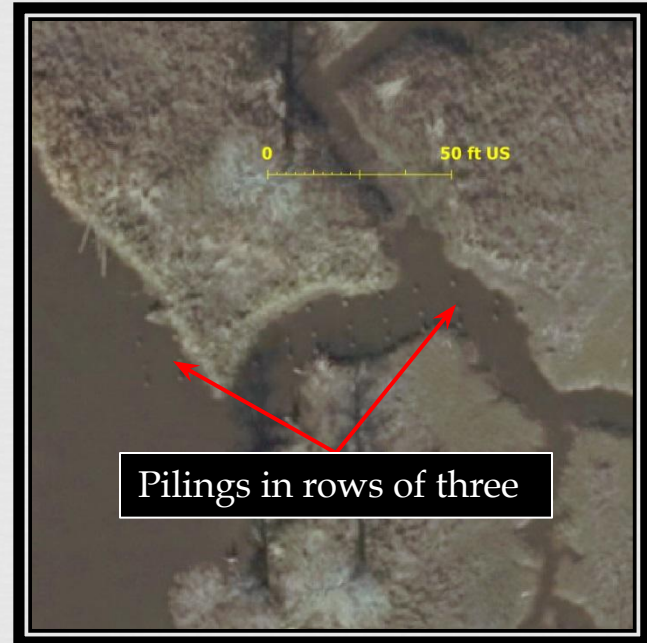
Close Up and Aerial View of the Remains of the Redmond Creek Trestle

3/14/2006; Tide at Wilmington -0.05 ft

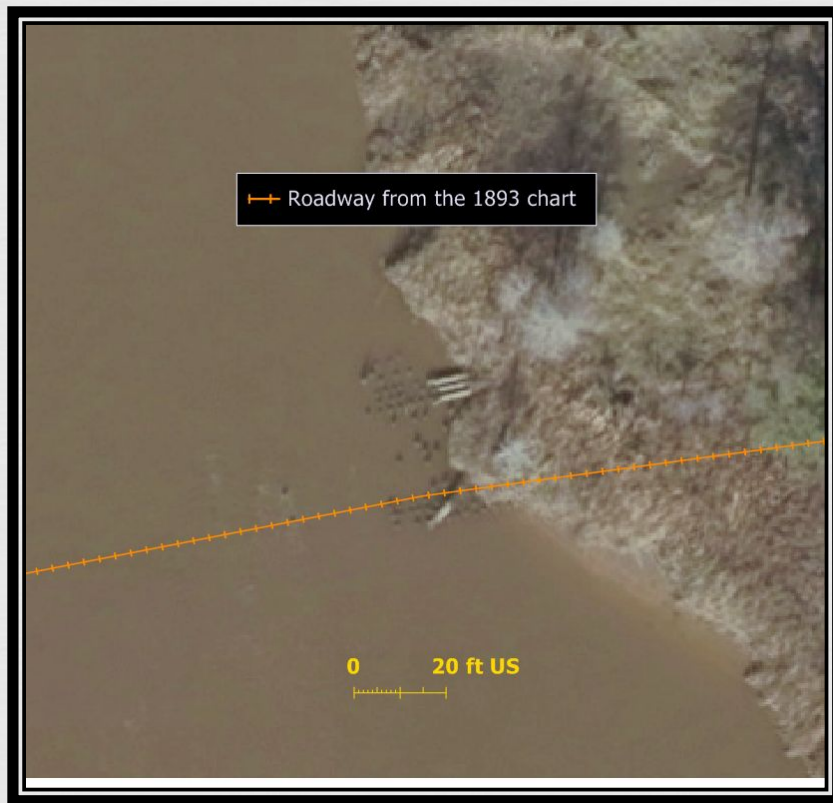
Verification by Geo-Comparison: The Brunswick River Trestle in Relation to the Charted W&M Roadbed

- Metrics
 - Charted roadbed is 12 ft south of center of trestle
 - Remains measure 37 ft north to south and 20 ft east to west
 - There are three horizontal members and more than 50 pilings
 - Two pilings are 35 ft from shore

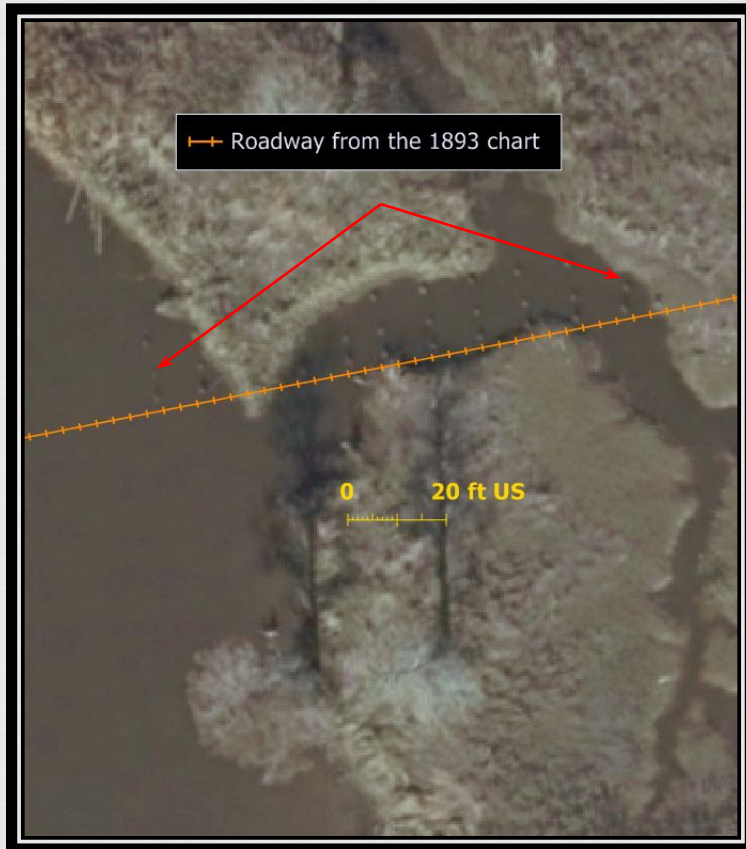
Verification by Geo-Comparison: The Redmond Creek Trestle in Relation to the Charted W&M Roadbed

- Charted roadbed is 8 ft south of center of remains
- 6 pilings on Redmond Creek
- 23 Pilings on the branch creek
- Remains 91 ft long by 13 ft wide

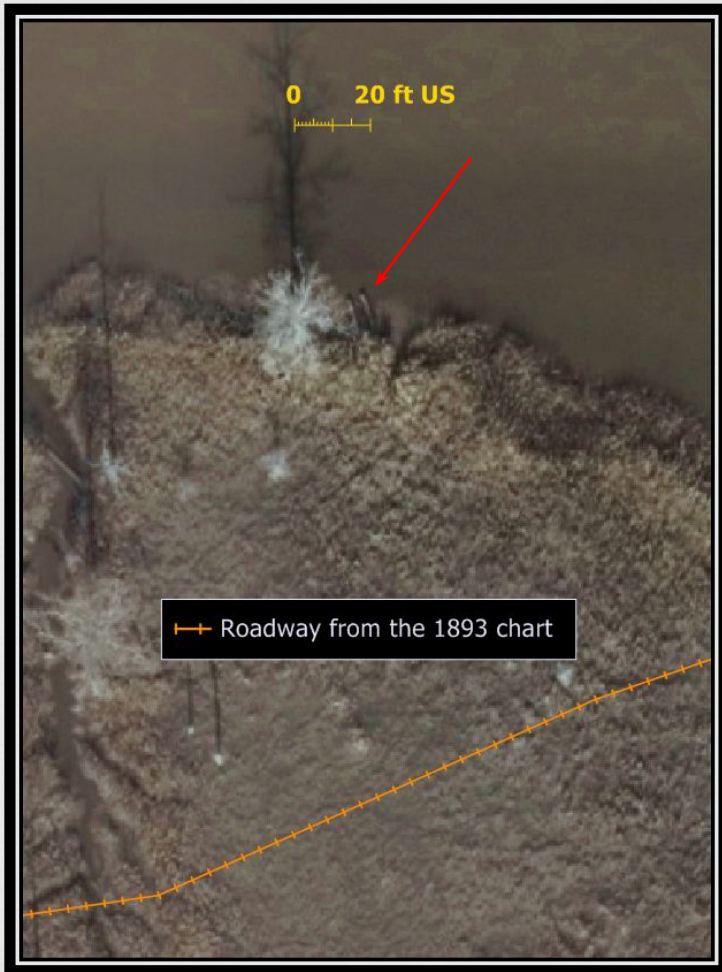
Verification by Geo-Comparison: The Alligator Creek Trestle in Relation to the Charted W&M Roadbed

- Charted roadbed is 120 ft south of trestle
- Part of the aerial view of the trestle is obscured by a tree; only two of the four horizontal members are visible

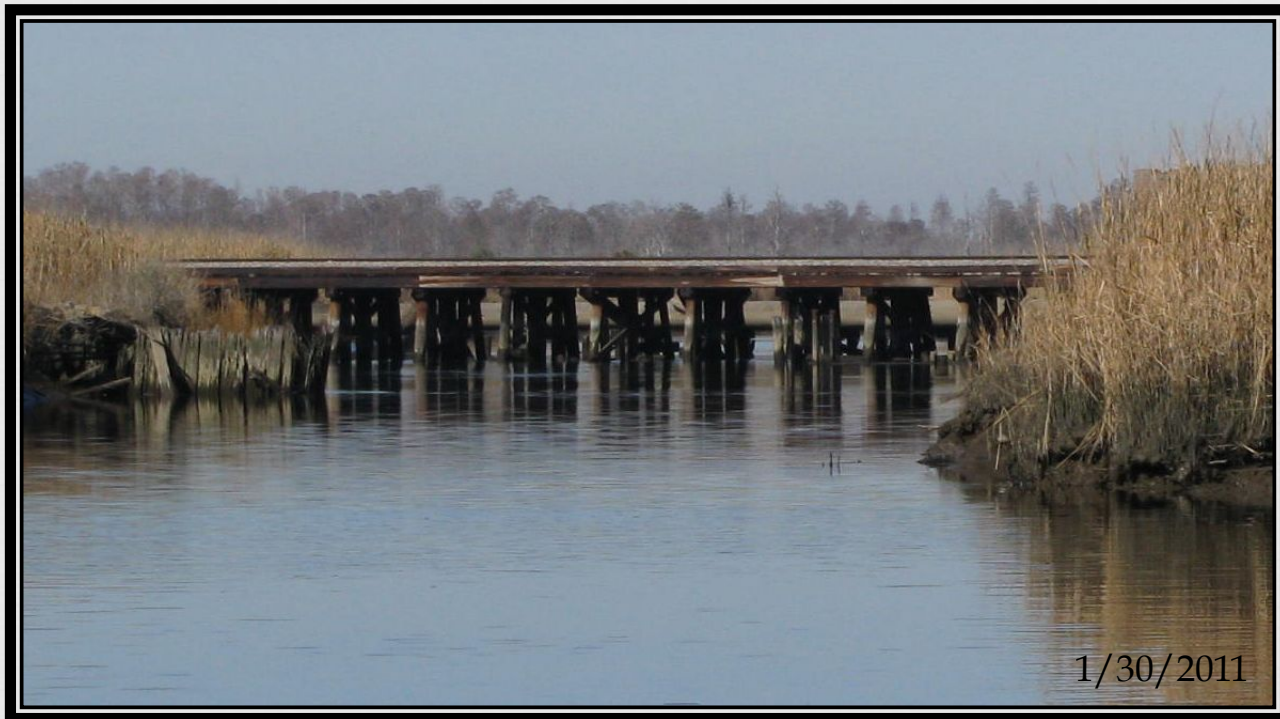
The W&M Alligator Creek and Redmond
Creek Trestles may have looked similar to
this

First trestle east of the Cape Fear Railroad Bridge on the CSX line. The trestle spans a large canal.

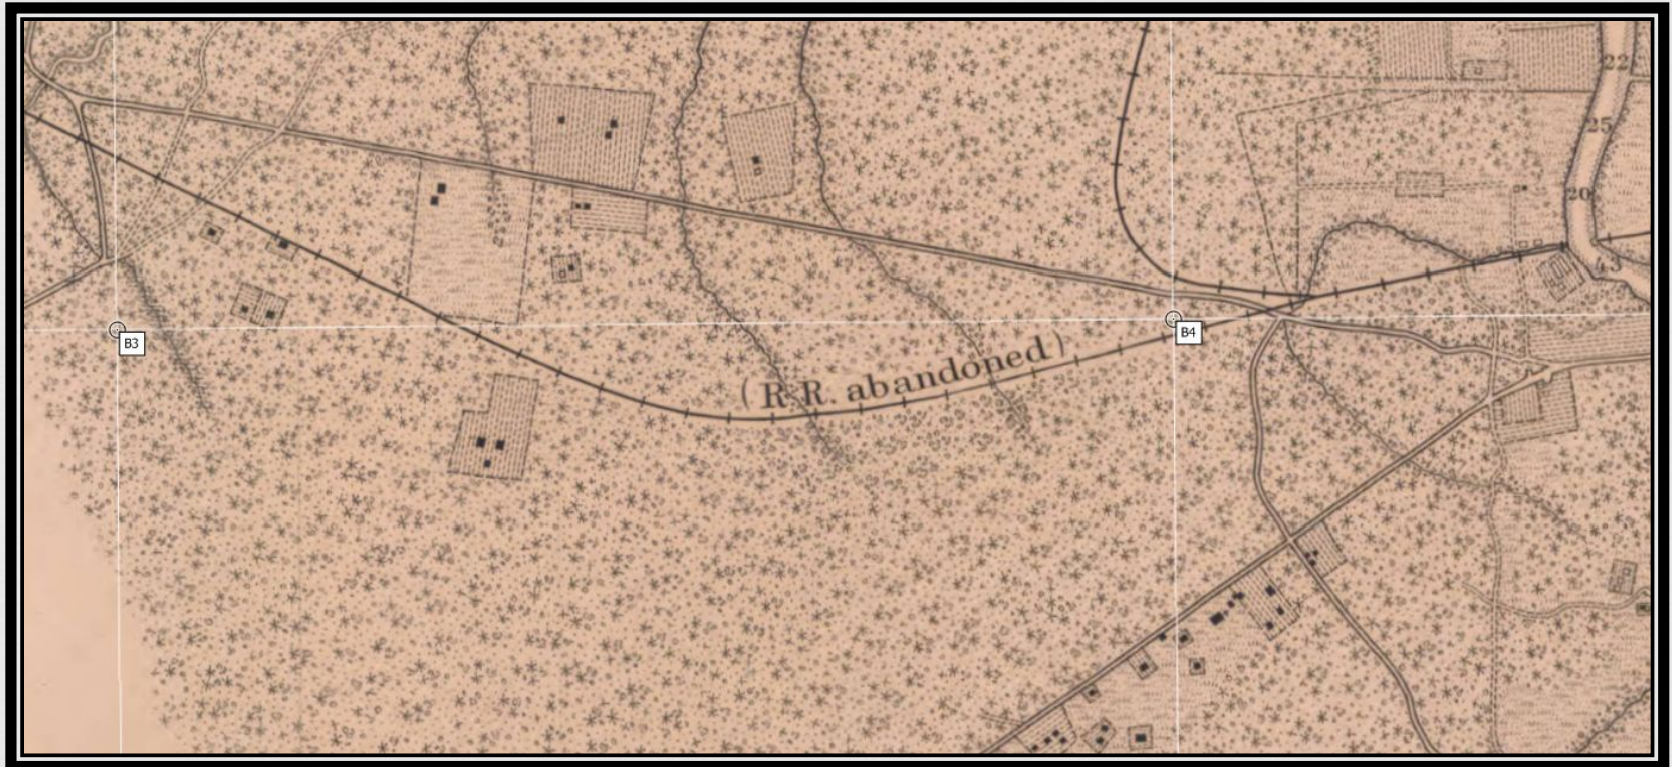
A section of the W&M on Chart 425 of 1893 in the area of present-day Leland near the junction of Rts 74/76 and 17
